# Creekstone Estate Stage 10, Tarneit, Victoria

Level 1 Inspection & Testing Report

18 April 2026

### Creekstone Estate, Stage 10, Tarneit, Victoria

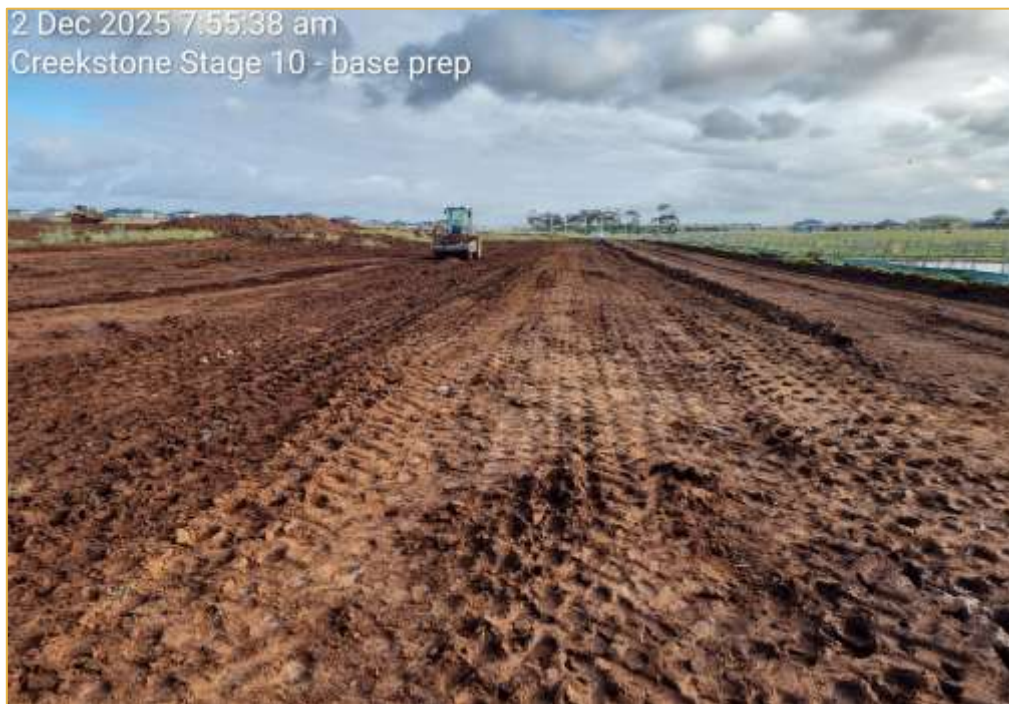
Subgrade preparation works were completed using an onsite scraper. The fill placement zones underwent stripping of topsoil, vegetation and organics until a base comprising residual Newer Volcanic Group logged as Silty CLAY / CLAY (CH), high plasticity, brown to light brown was achieved.

Figure 2: Subgrade Preparation (Source: C&T)

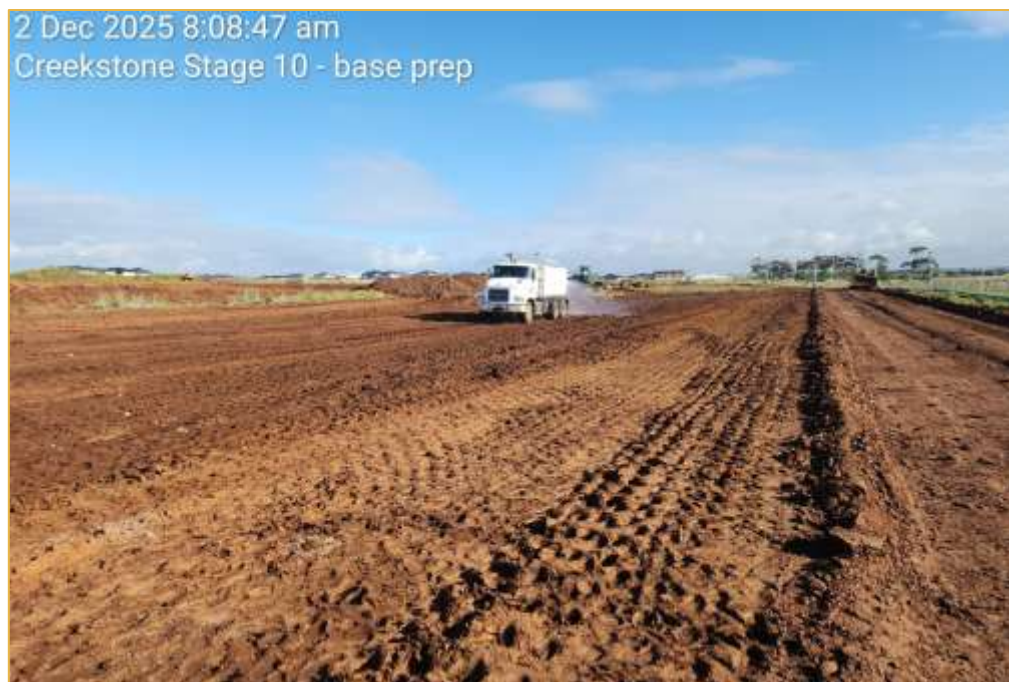
The subgrade was subsequently scarified, moisture conditioned and proof rolled using a fully loaded water truck (approx. 12 tonnes). No soft spots, deflections, springing or rutting was observed and the subgrade was considered suitable for fill placement.

Figure 3: Moisture Conditioning Subgrade Prior to Fill Placement (Source: C&T)

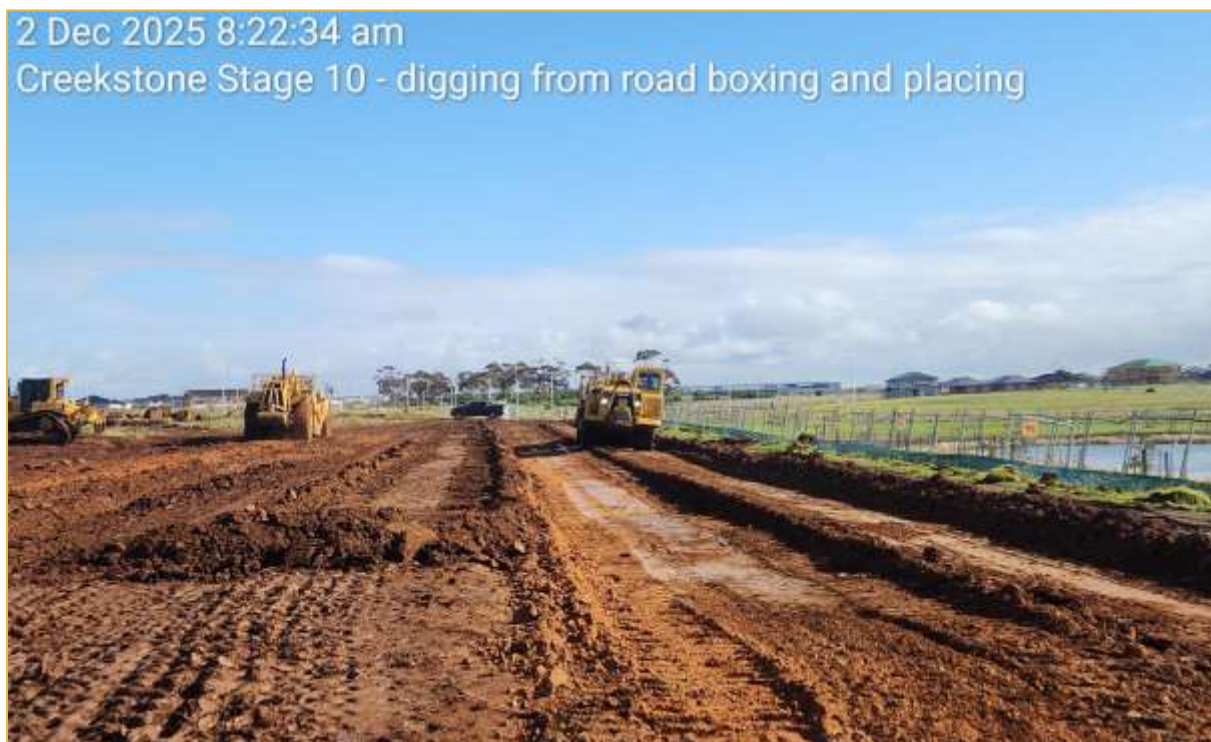
The filling process was generally consistent throughout the project. The fill materials were spread over the placement zones using the onsite scraper, in loose layers not exceeding  $\approx 100$  mm thickness. A water cart was used to moisture condition the base prior to fill spreading at the commencement of each day's works, as well as after spreading each layer of fill.

Figure 4: Spreading of Fill Material Across the Placement Zones (Source: C&T)

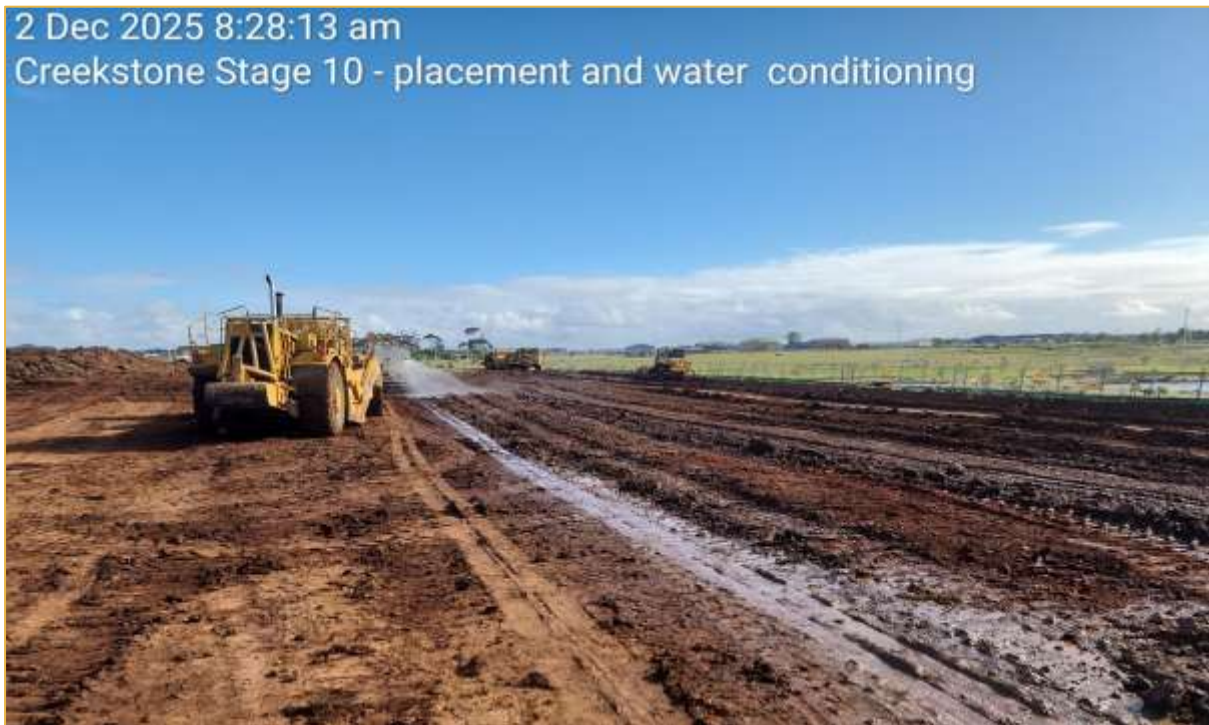
Figure 5: Spreading of Fill Material & Moisture Conditioning (Source: C&T)

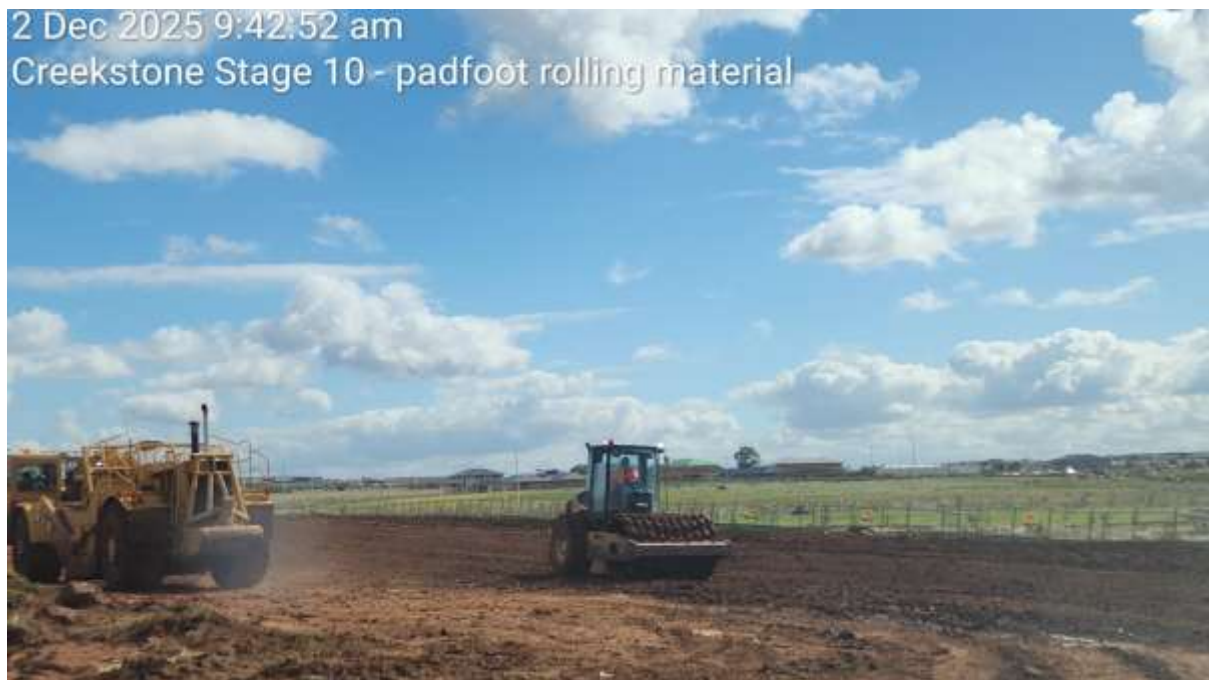
The Padfoot Roller was used to compact the fill, applying a minimum of 6 – 10 passes per layer observed. The fill materials were compacted to achieve a composite layer measuring approximately 200 mm. Field density testing was subsequently carried out on each composite 200 mm thick layer.

Figure 6: Fill Compaction (Source: C&T)

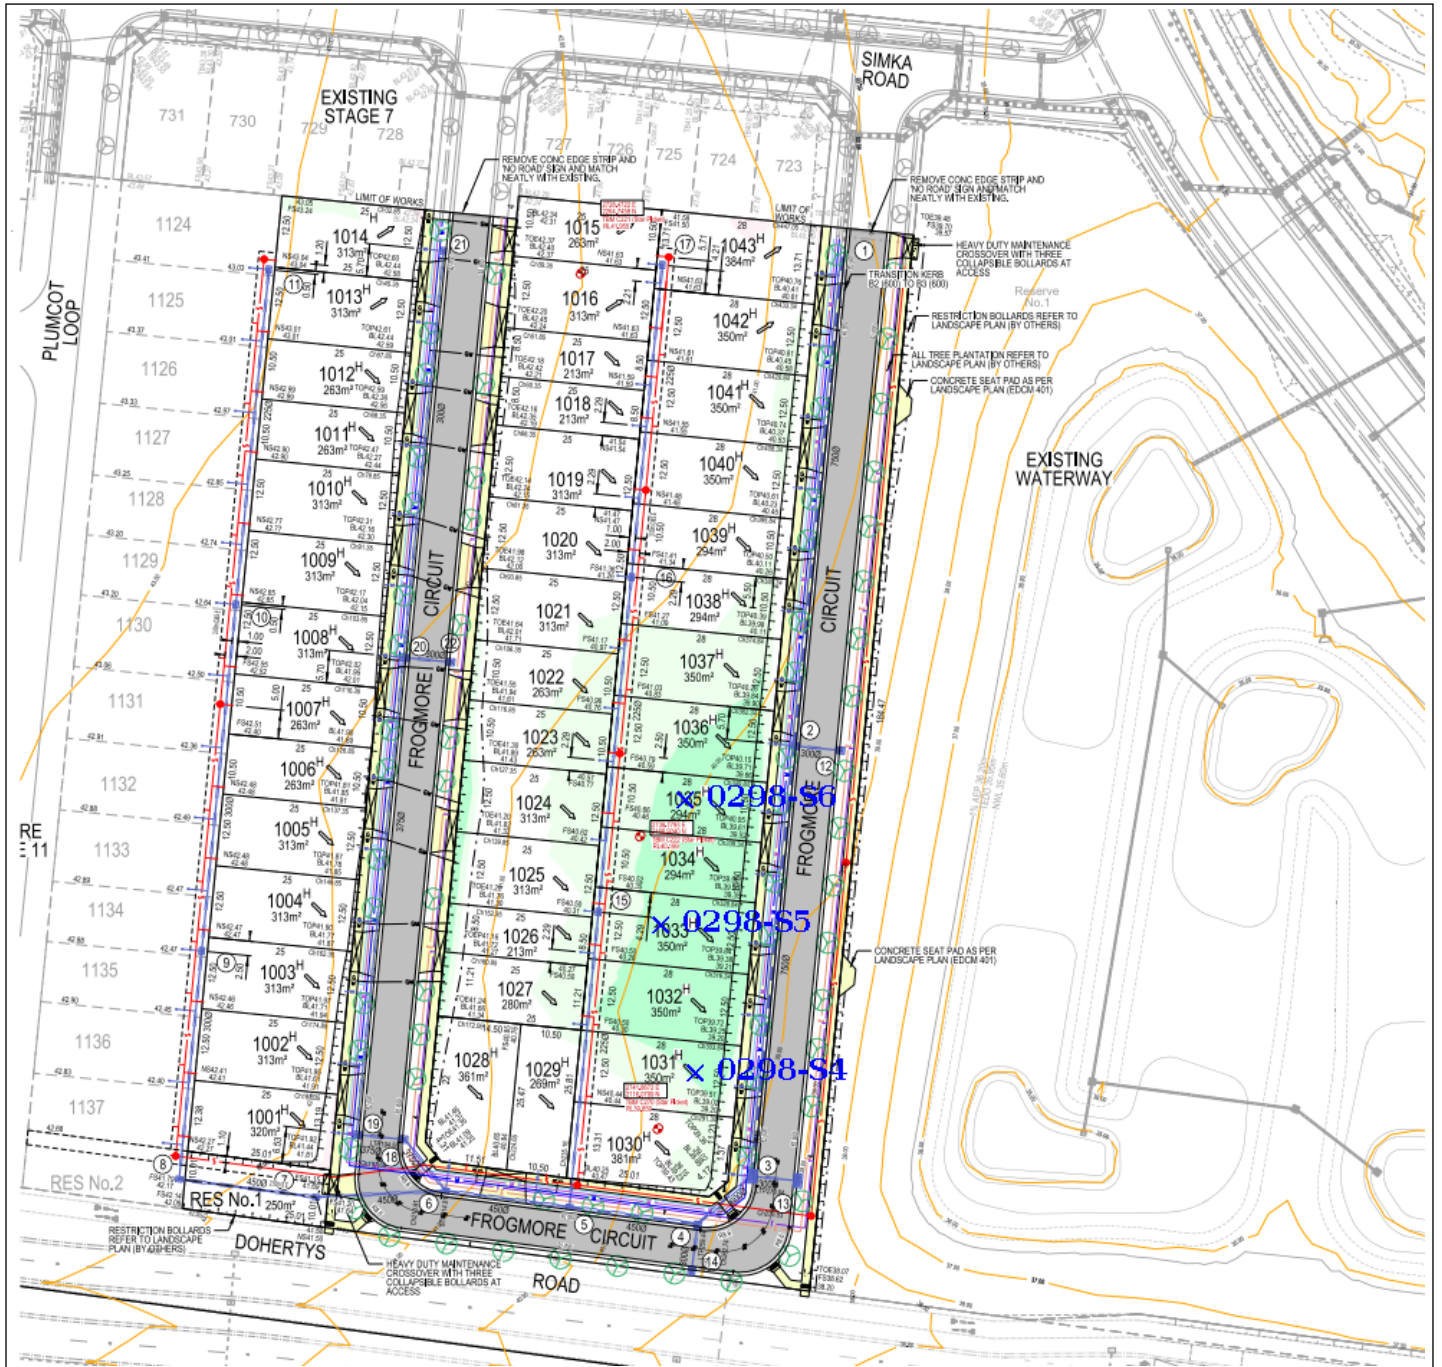
# Sample Locations Plan

x - approximate test location
