# Creekstone Estate Stage N11, Tarneit, Victoria

Level 1 Inspection & Testing Report

## Level 1 Inspection & Testing Report Creekstone Estate Stage N11, Tarneit

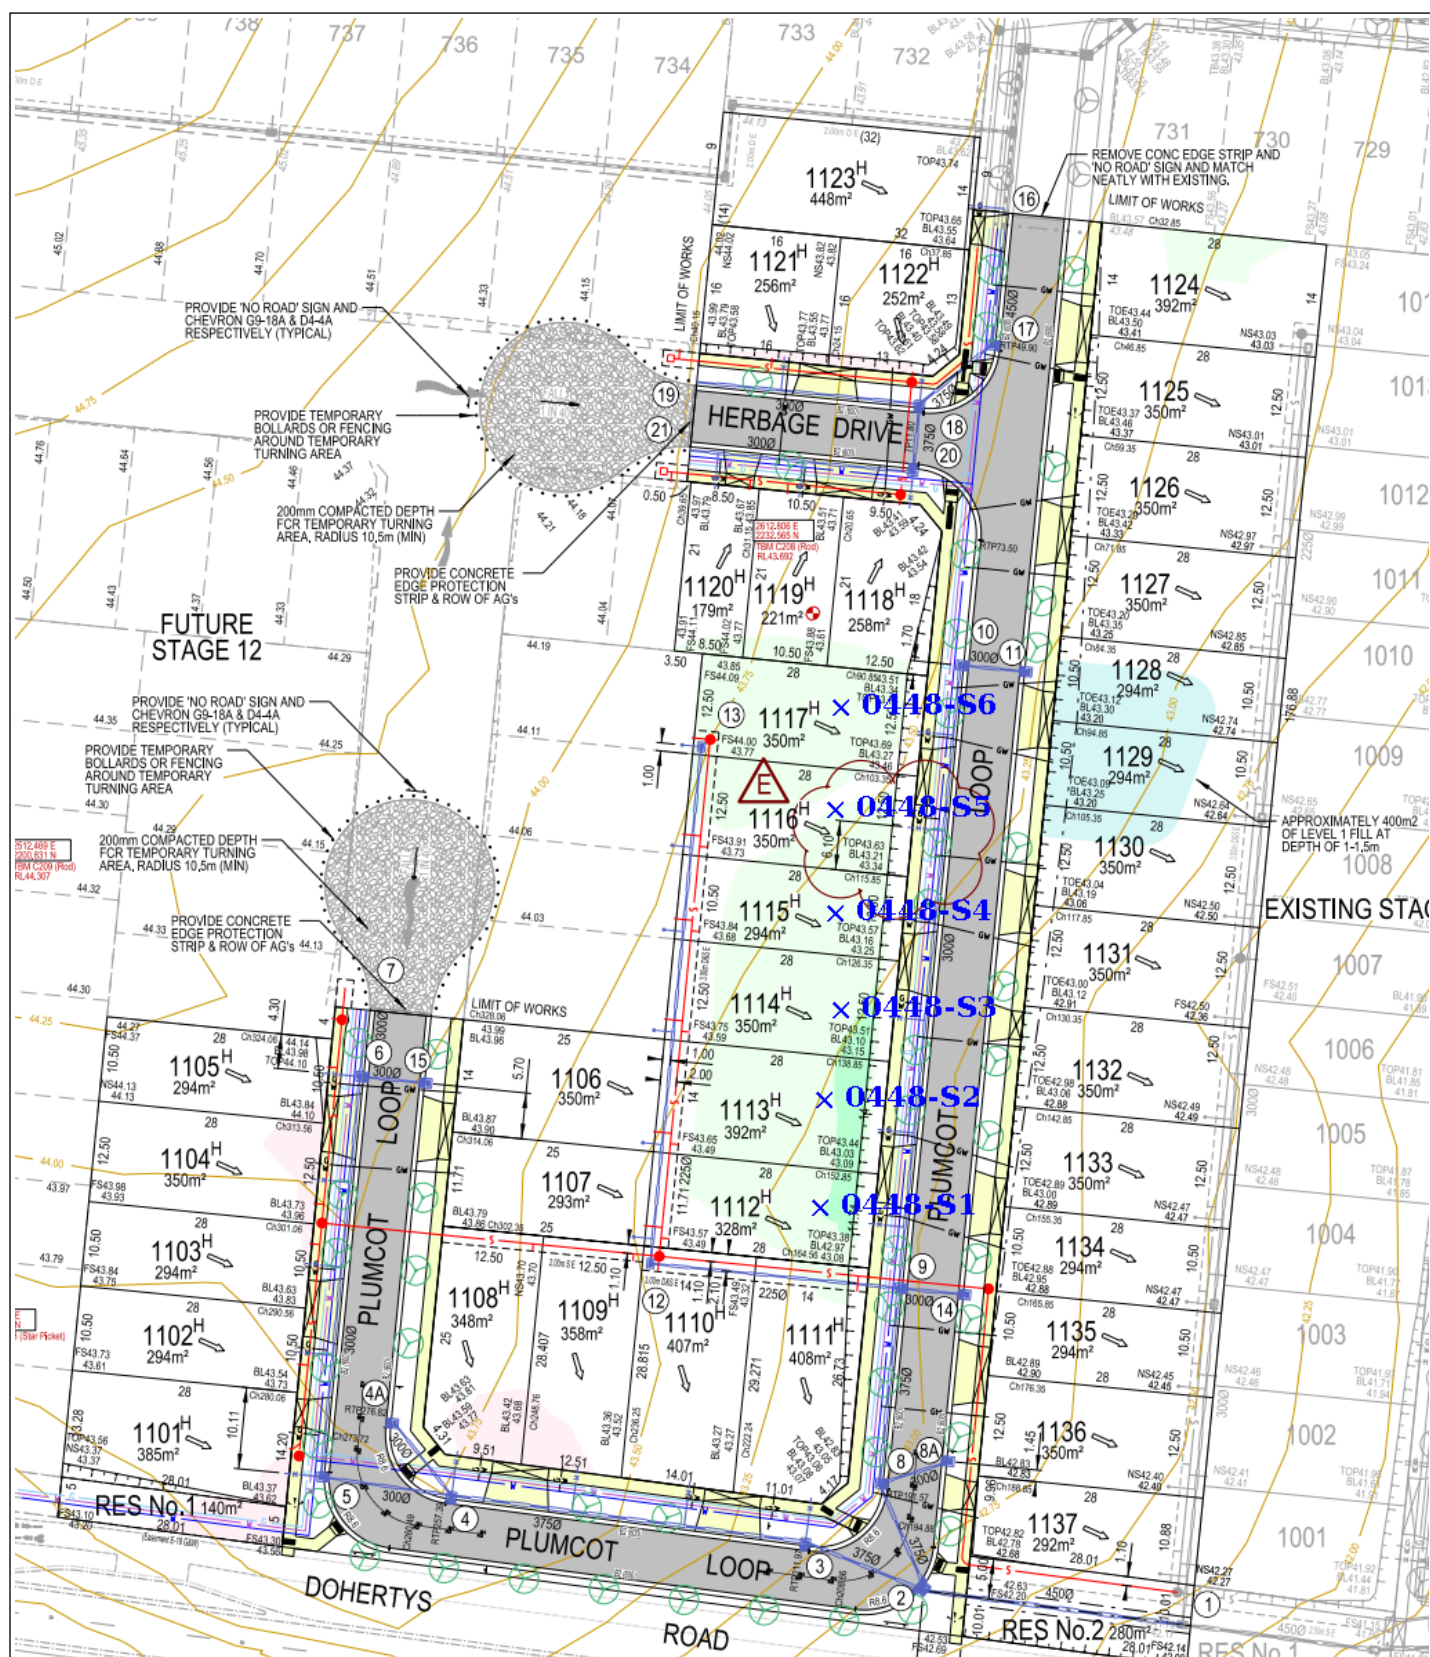
**x - approximate test location**
